805 MHz cavity refurbishment

NFMCC collaboration meeting

1-09

Bob Rimmer

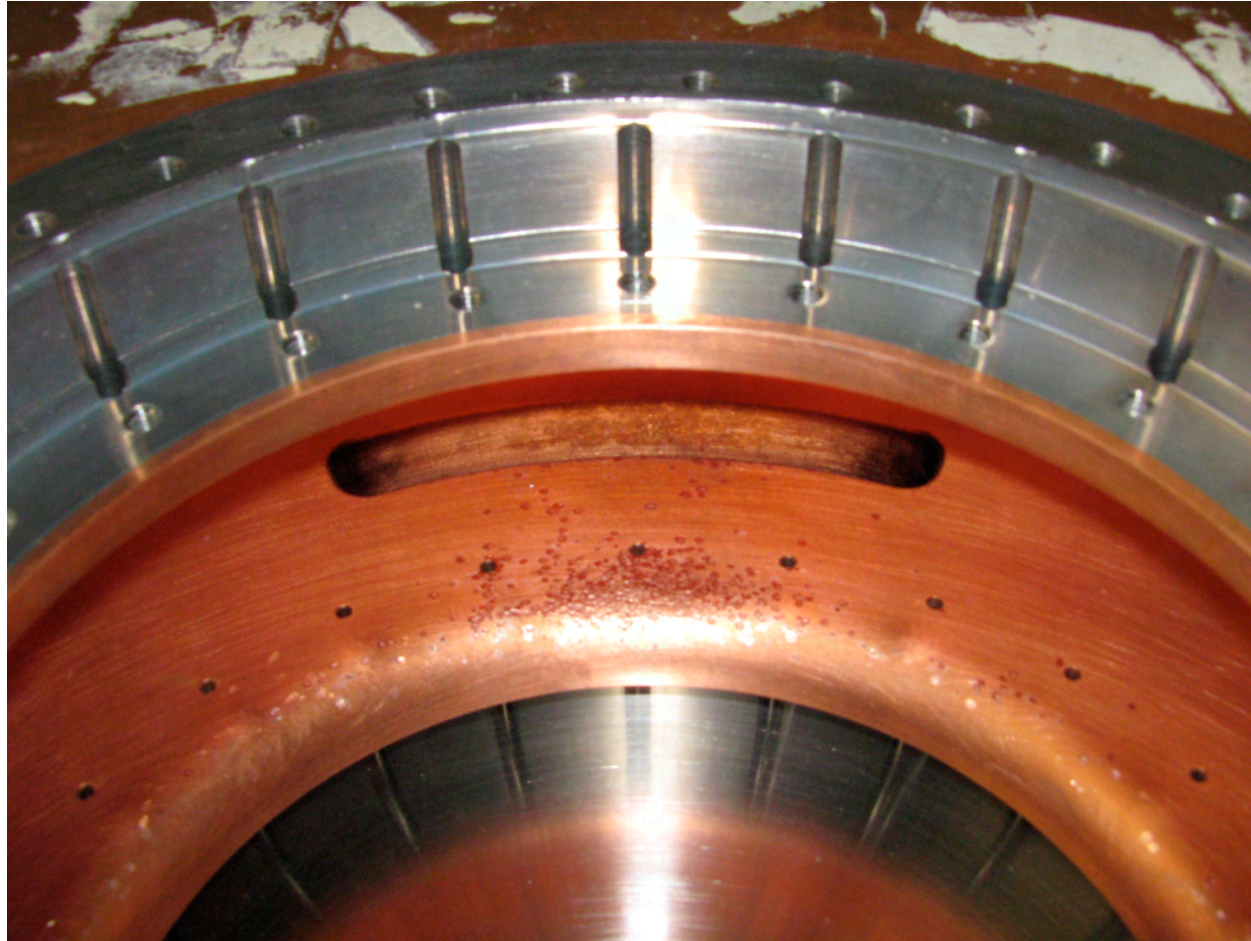
# 805 Cavity “before”

- Cavity was heavily arc damaged after many runs at high magnetic field
- Heavy pitting on button holder, irises (with slight “dipole” asymmetry)
- Further inspection revealed significant damage in the coupler region
- May explain why all button tests followed similar processing curve with magnetic field

- Polish out all visible iris damage
- Polish out arc marks in coupler region
- Polish out arc marks in coupler extension
- Cut inner and outer blend radii on coupler
- Ultrasonic clean and DI water rinse (HPR)
- Clean room assembly (to be done)
  - Cu and Be windows available
  - Button holder needs to be re-worked or re-made
- No electropolishing
